Climate Change Building Adaptation – Case Study

Rohan Prathapasinghe

Building Adaptation Works to Box Hill Town Hall

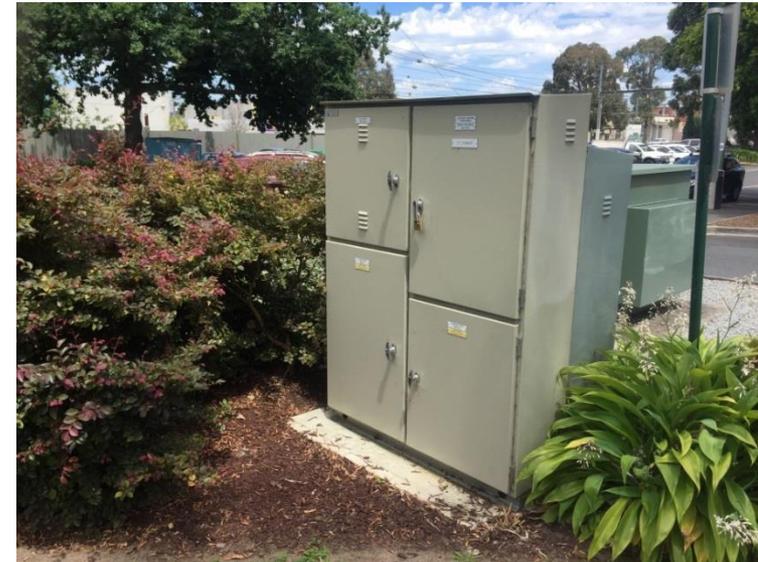
- Works have been undertaken so that the town hall is now generator ready (requirements of emergency relief centre taken into consideration)
- Standby generator has been tested on site (250 amps)

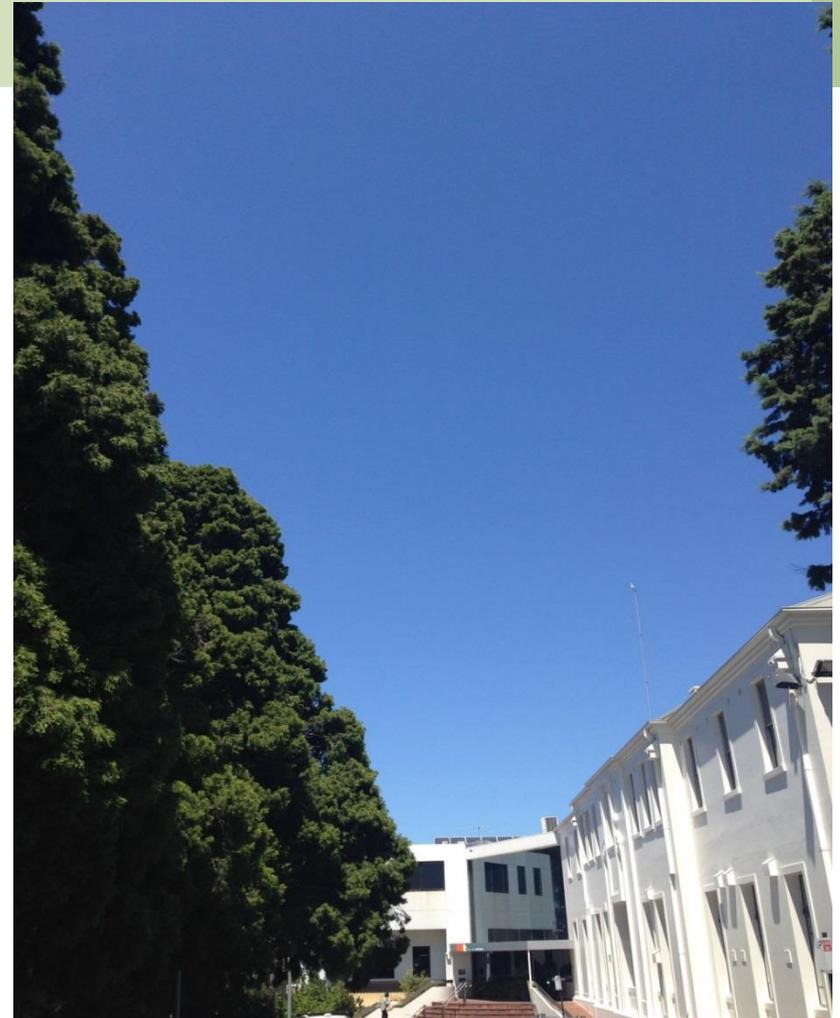
Works

- Installation of protective glazing film to windows to prevent heat transfer to internal spaces and to protect from tree limbs and other impact items.
- A regular tree pruning program is in place.

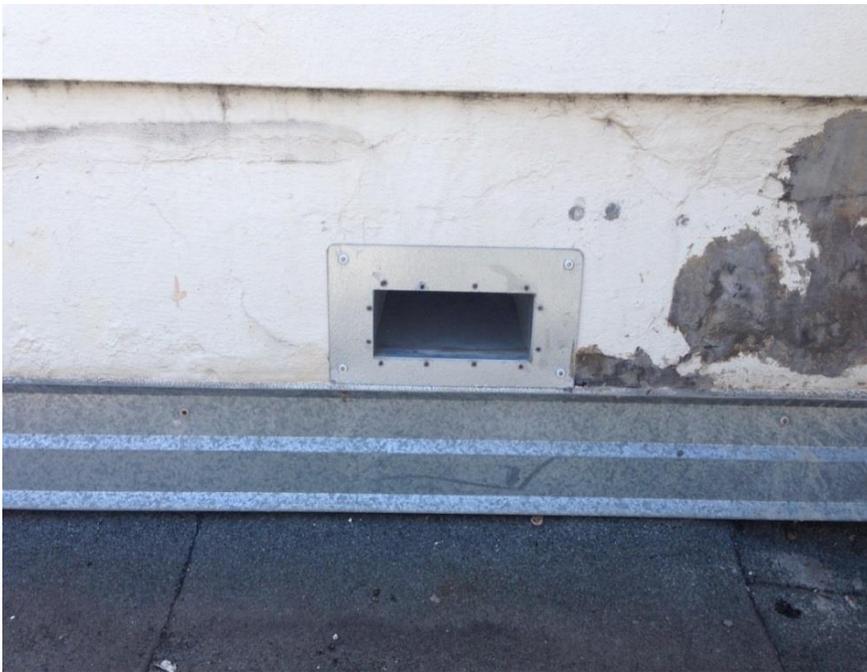
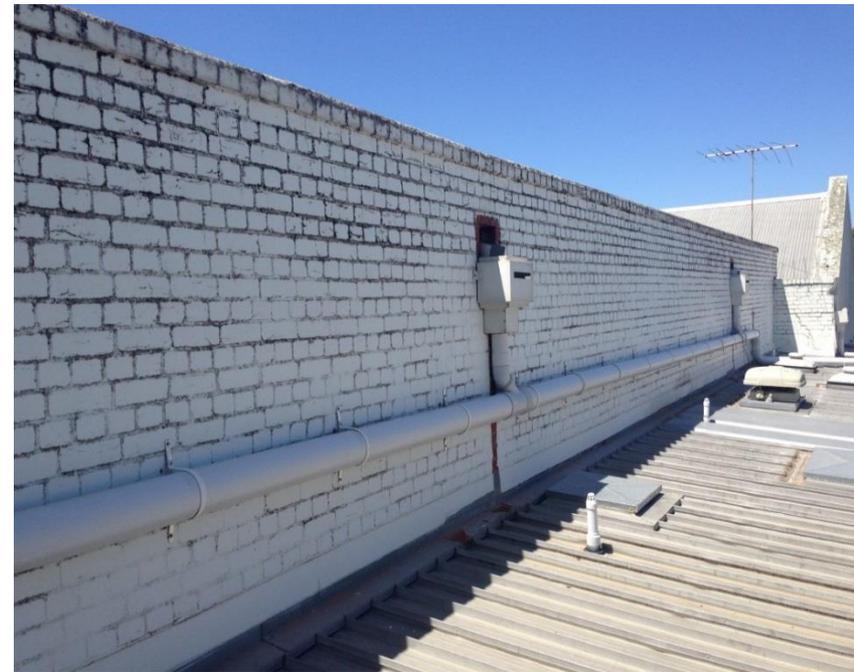
Challenges cont..

- Contractor appointment and understanding of climate change adaptation

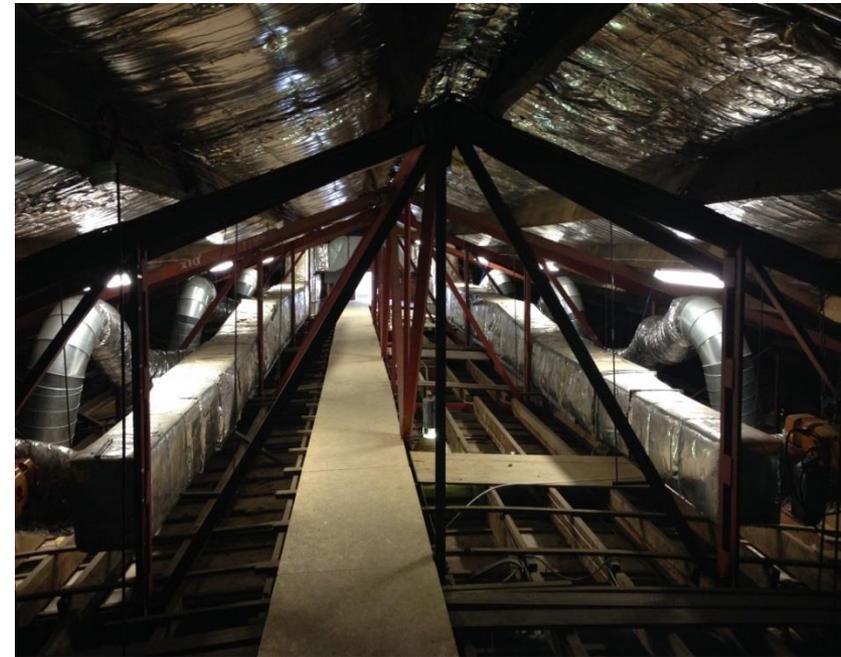
OH&S when implementing projects
